**SALMON  
HABITAT LIMITING FACTORS  
WATER RESOURCE INVENTORY AREA 6  
ISLAND COUNTY**

**WASHINGTON STATE  
CONSERVATION COMMISSION**

**April 2000**

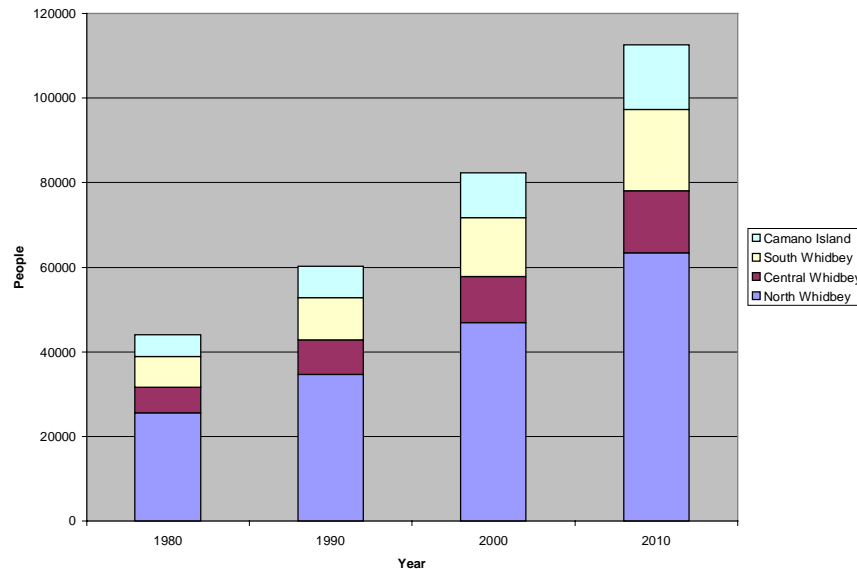
Figure 2. Projected population growth in Island County sub-regions, 1990-2010 (Kearsley and Hossley 1995).

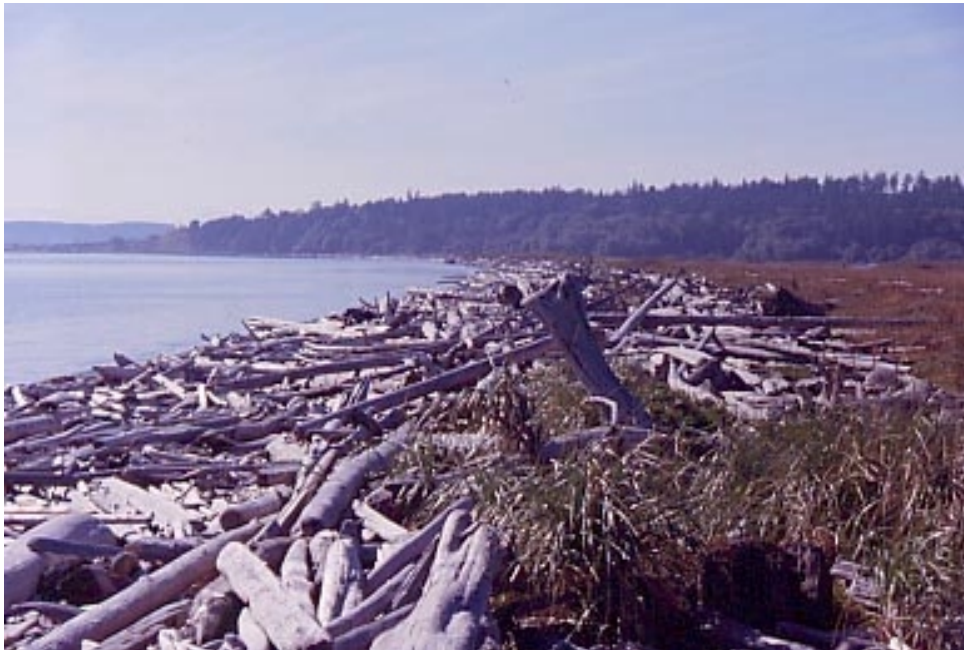
Figure 3. Crescent Harbor shoreline.

*Estuarine and Nearshore Habitat.* Pioneer Way, the tidegate and the system of dikes and ditches within the estuary have altered natural tidal flooding processes. The nearshore habitat is presumed to be in good condition (Figure 3).

- Fill the ditch (immediately north) that runs parallel to the road.
- Explore with the Navy and the City of Oak Harbor the feasibility of removing the sewage lagoon, restoring the grade to facilitate restoration of the entire estuary system.
- Explore the possibility of removing the left creek tributary that drains from the Sleeper Road wetlands to the county drainage ditch and unmaintained agricultural channels.
- Identify and protect (through acquisition or easement) the headwaters of Crescent Creek.
- Develop a plan to restore and manage Crescent Creek for the reintroduction of anadromous salmon.
- Provide protection for the riparian buffer through acquisition or conservation easements.

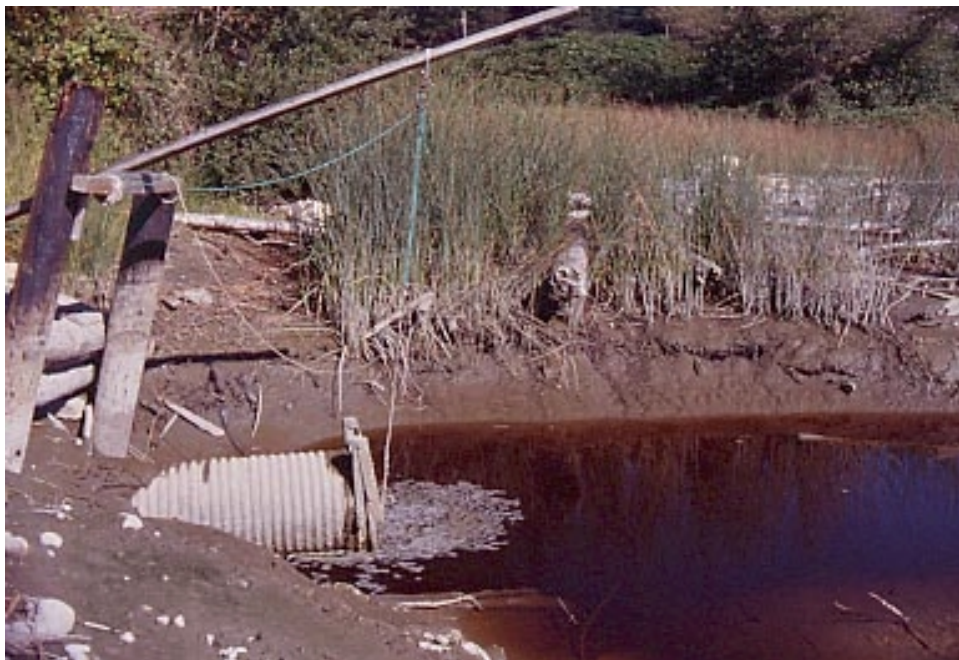
*Access.* Fish passage is partially or wholly blocked to Cultus Creek by a tidegate at the north end of the dike (Figure 4). The culverts that have been installed on both sides of Bailey Road also impede fish passage. Upstream of Bailey Road, a private landowner has constructed an earthen dam. Water from upstream drainage flows through a perched pipe in the dam.

Figure 4. Tidegate at the mouth of Cultus Creek.

*Freshwater and Tidal Flooding.* The privately-owned dike and tidegate are preventing tides from entering the estuary.

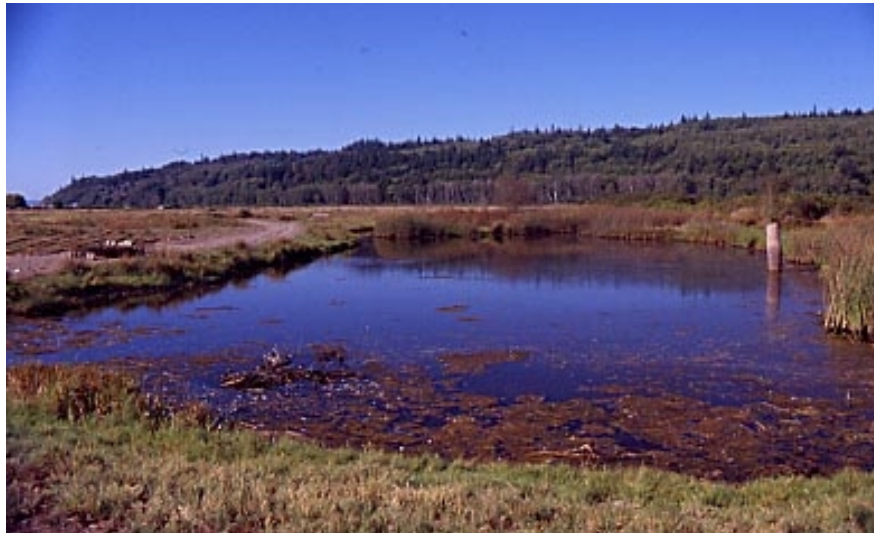
*Riparian Conditions.* A riparian survey has not been conducted on Cultus Creek. Natural vegetation within the estuary has been replaced by pasture (Figure 5). Exotic species are also present. The riparian corridor above the estuary is presumed to be in relatively good condition (with some impact from residential development).

Figure 5. Cultus estuary behind existing dikes.

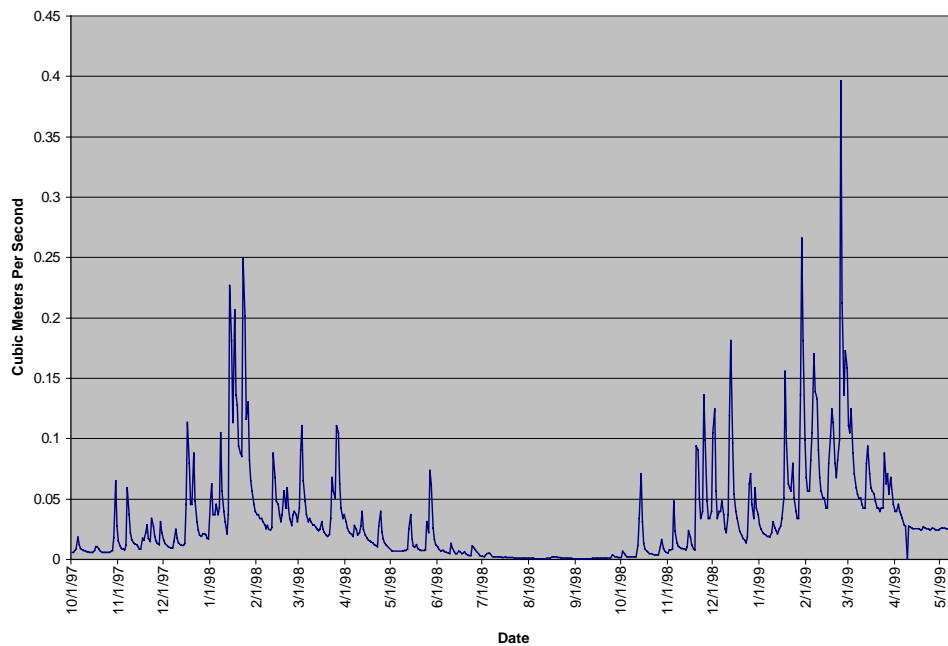
*Hydrology.* Cultus Creek is one of only two fish-bearing streams in WRIA 6 in which streamflow data were located for this report. The data were recorded from a USGS stream gage on Cultus Creek upstream of the mouth (Sumioka 1999). The gage was installed to collect data for the Island County groundwater recharge study. The hydrograph shown in Figure 6 depicts streamflow from October 1, 1997 through May 11, 1999. During this time period a peak flow of  $0.4 \text{ m}^3/\text{s}$  was recorded on February 24, 1999. Between June 30, 1998 and October 12, 1998, streamflow fell below  $0.003 \text{ m}^3/\text{s}$  for

Figure 6. Cultus Creek streamflow, October 1, 1997 to May 11, 1999 (Sumioka 1999).

all but 9 days, with the lowest flows recorded at  $0.0006 \text{ m}^3/\text{s}$ . The average flow between October 1, 1997 and September 30, 1998 was  $0.02 \text{ m}^3/\text{s}$ . The headwaters of the stream are derived from hillside springs (Kearsley 2000). Wetland systems, like those found downstream of Bailey Road, are also presumed to contribute base flow to the stream.

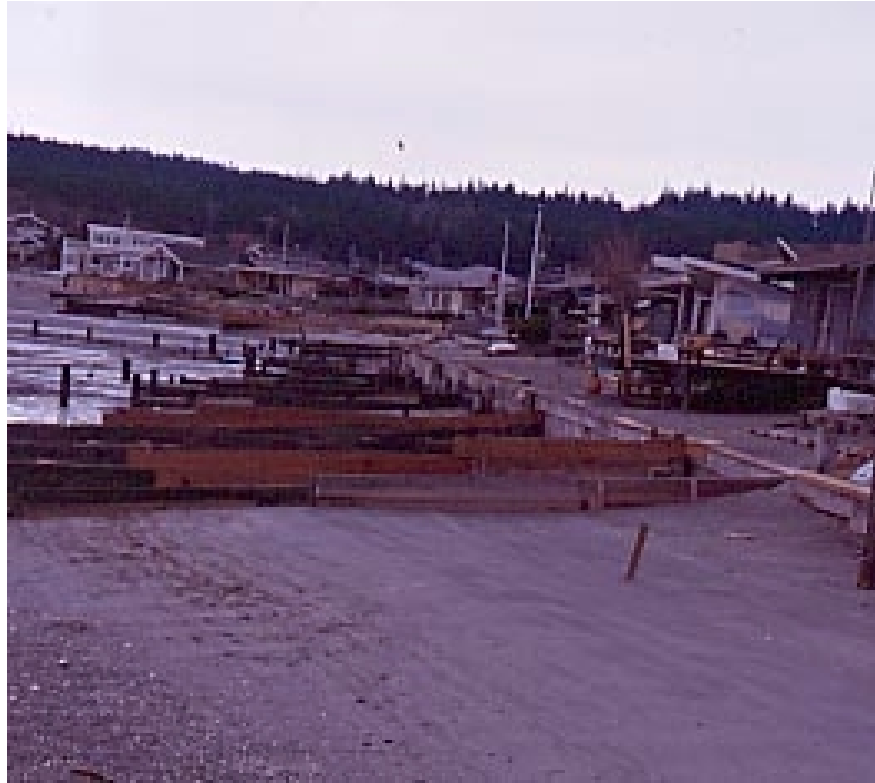
Figure 7. Sandy Hook residential development at Cultus Bay.

*Estuarine and Nearshore.* The Cultus estuary has been converted to pasture land through the construction of dikes and the tidegate. The shoreline along Sandy Hook has been heavily modified by residential development and groins (Figure 7). A private harbor has also been constructed east of the sand spit.

- Acquire (or obtain conservation easements) to protect and restore the privately held parcel within the Cultus Bay Estuary.
- Remove the dike and culvert to allow for fish passage and tidal flooding. If access to the home on the spit is required, bridge the dike or provide for an alternate route.
- Design and implement a vegetation monitoring program for the estuary.
- Repair the existing culverts on Bailey Road.
- Remove the private dam above Bailey Road.
- Identify and protect the headwaters of Cultus Creek.
- Provide protection of the riparian stream buffer through acquisition or easement, and explore cooperative restoration partnerships with local landowners.
- Develop a plan to restore and manage Cultus Creek for coastal cutthroat and the reintroduction of anadromous salmon.

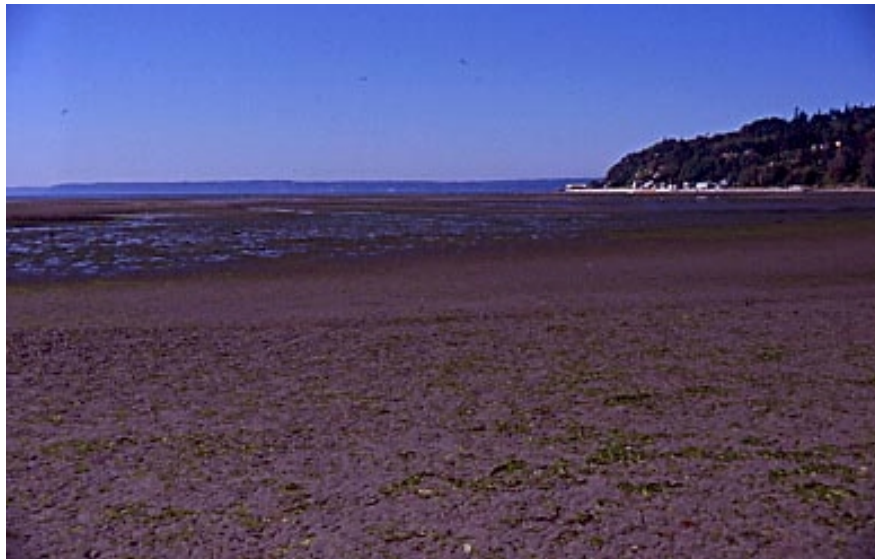
Figure 8. Cultus Bay at low tide.

The unaltered portion of Cultus Bay is in relatively good condition (Figure 8).

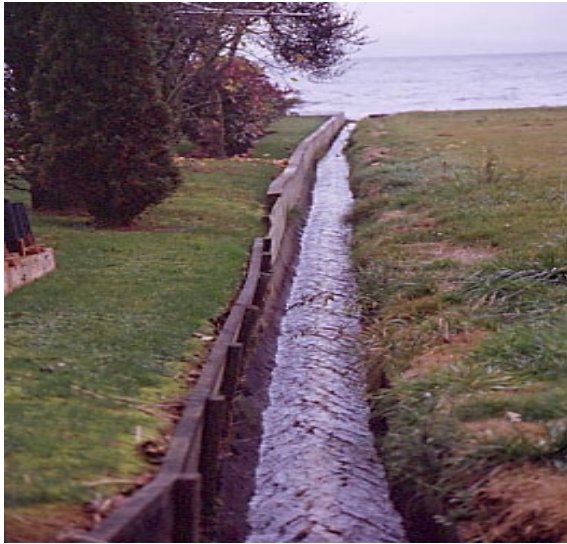
*Channel Conditions and Sediment.* The channel conditions are presumed to be in good condition except for the lowermost reach where the stream has been diverted into an underground flume and riparian vegetation is absent.

Figure 9. Flume above mouth of Deer Creek.

- Acquire the property upon which the flume is sited. Remove the flume and perched culvert at Columbia Beach to re-establish the stream channel at the mouth of the creek.
- Provide for fish passage at Anderson Dam.
- Remove exotic vegetation where present and revegetate the riparian corridor.
- Identify and protect (through acquisition or easement) the headwaters of Deer Creek.
- If fish passage is obtainable, develop a plan to restore and manage Deer Creek for coastal cutthroat and anadromous salmon.
- Provide protection for the riparian buffer through acquisition or conservation easements, and develop partnerships with landowners for riparian restoration projects.

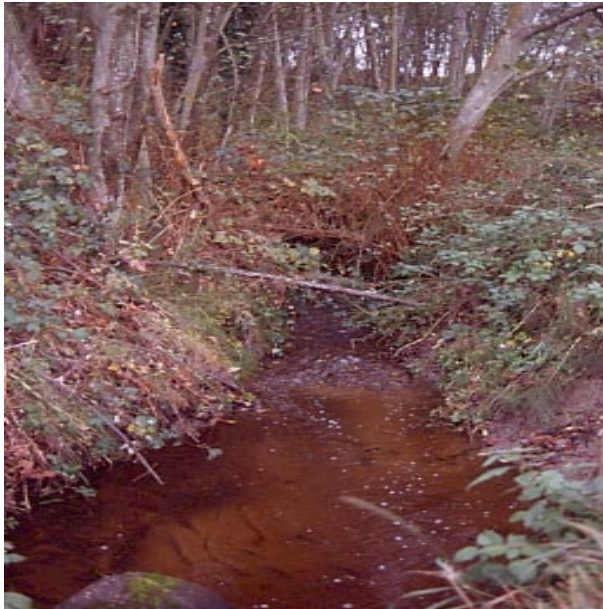
*Riparian Conditions.* The Deer Creek riparian corridor is relatively intact throughout most of its length (Figure 10). There have been some limited impacts from residential development.

Figure 10. Deer Creek riparian corridor.

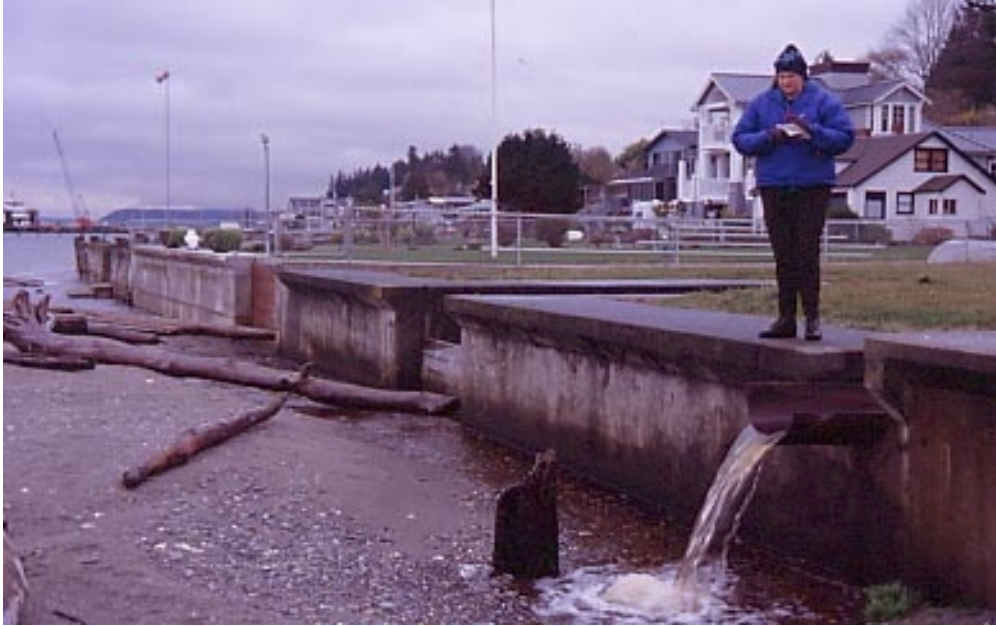
Figure 11: Deer Creek nearshore and mouth.

*Estuarine and Nearshore.* There is no estuary associated with this drainage. The nearshore habitat has been heavily modified from residential development (Figure 11).

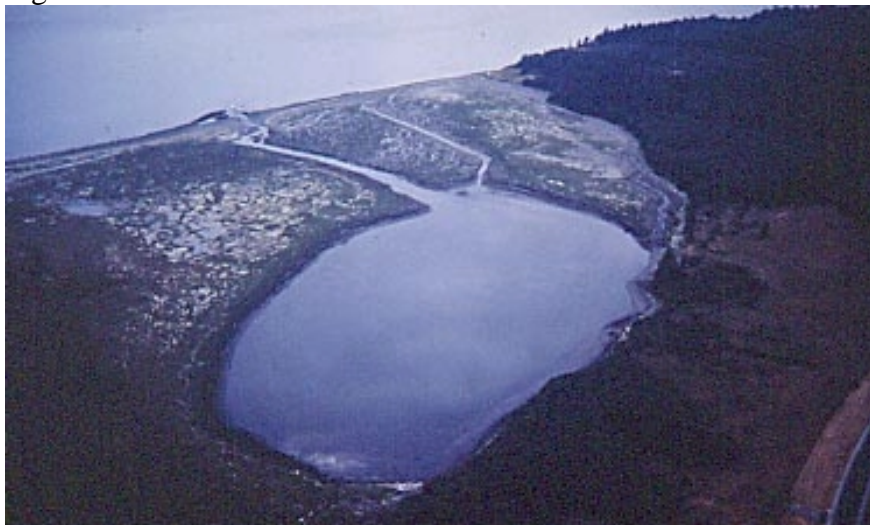
Figure 12 Lake Hancock.

- Lake Hancock is the best remaining example of a salt marsh ecosystem in WRIA 6 (Figure 12). This ecosystem could be established as a control site for future estuary restoration and monitoring efforts at other locations in WRIA 6.0

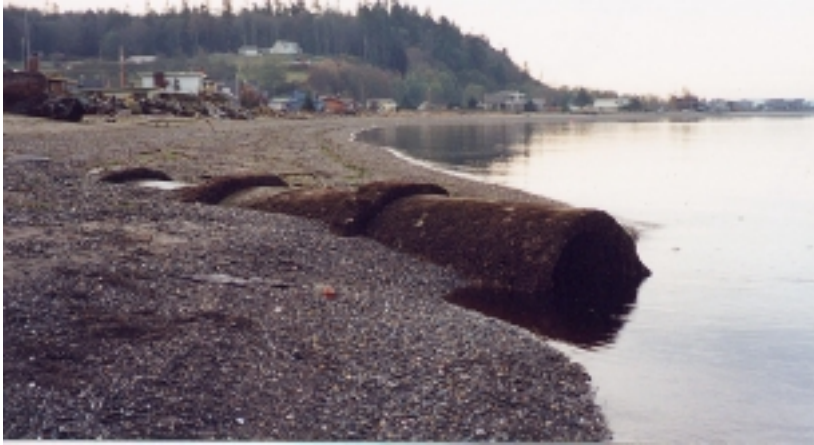
Figure 13. Tidegate at mouth of Maxwellton Creek.

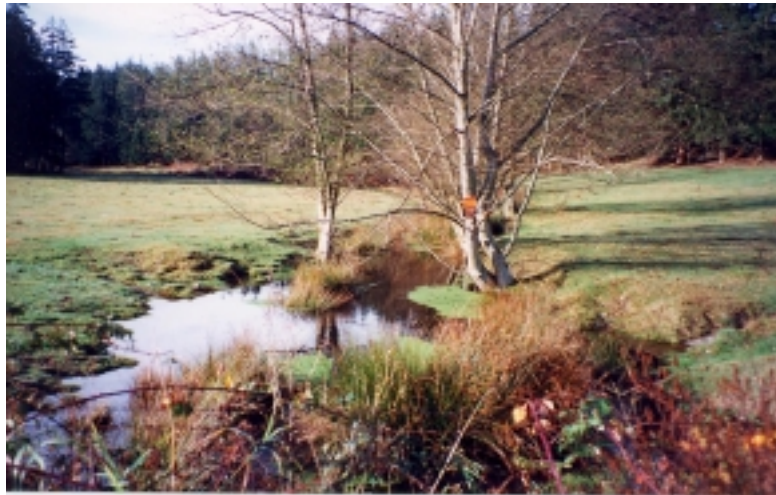
*Riparian Conditions.* The riparian habitat is a mosaic reflective of the mixed land uses in the sub-basin (Kearsley 2000). Agriculturally dominated areas tend to have pasture to the creek edge (Figure 14). Some have small hedgerow buffers of mixed vegetation. Residential areas vary in their treatment of the riparian buffer. Many landowners maintain a manicured buffer. Others have a mixture of trees and cleared underbrush or a wild buffer of invasive species. A few have maintained an extensive native buffer or preservation area. Many areas of the sub-basin remain undeveloped and have a mixed

Figure 14 Modified riparian area along Maxwellton Creek.

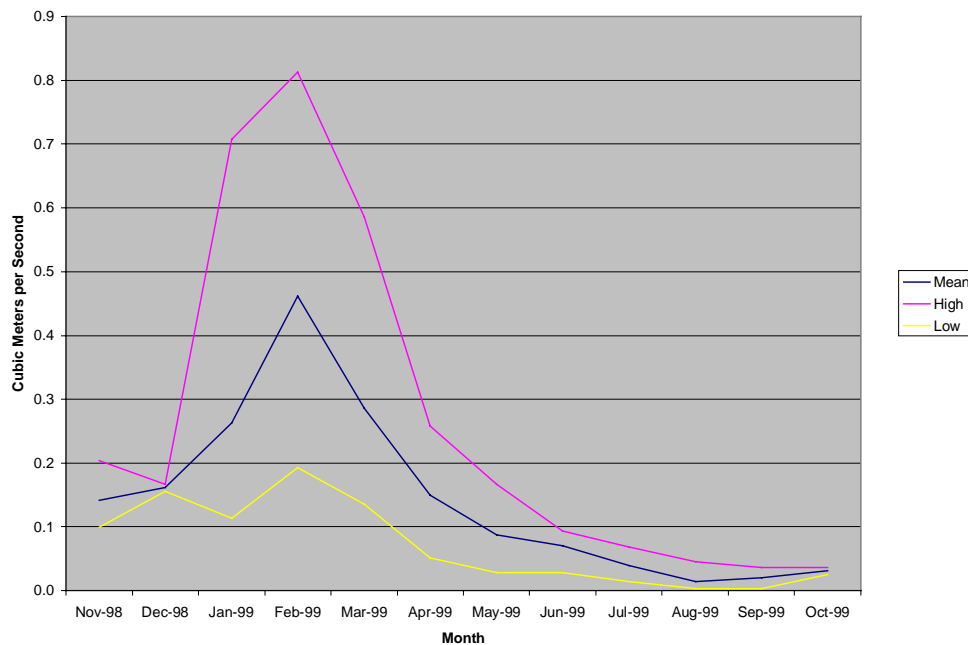
Figure 15. Maxwellton Creek streamflow, November 1998 through October 1999 (Barnes 1999).

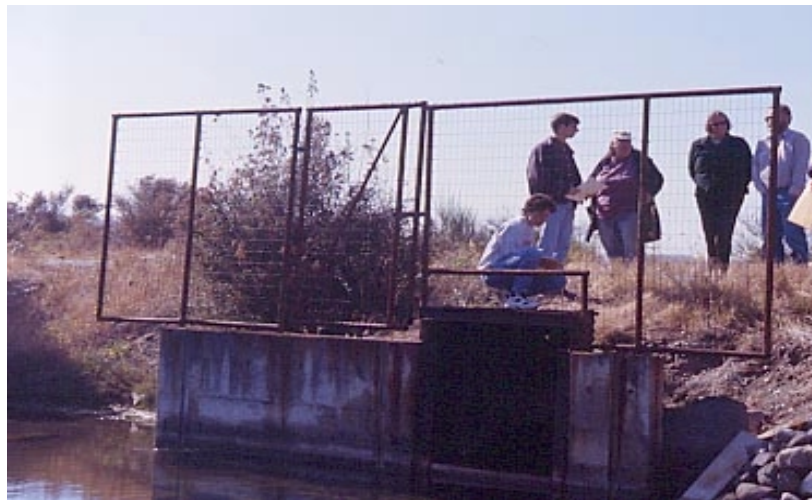
Figure 16. Tidegate at Kennedy Lagoon.

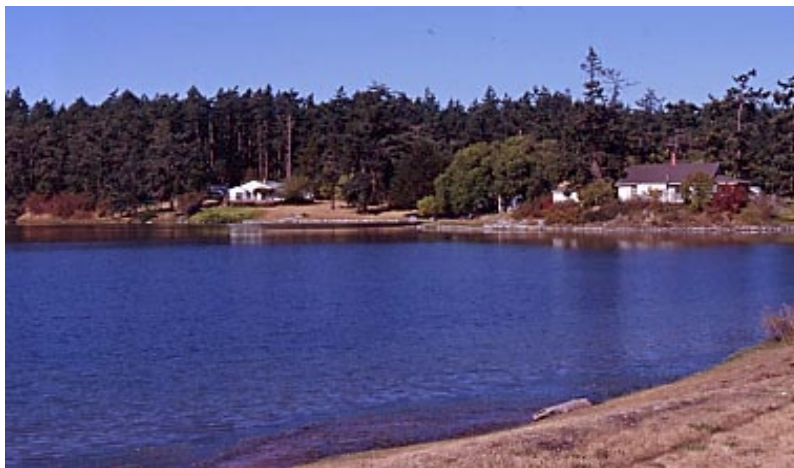
Figure 17. Kennedy Lagoon.

*Riparian Conditions.* There is virtually no riparian buffer separating Grasser's Lagoon from the surrounding roads. The riparian habitat at Kennedy Lagoon has also been removed or modified in the vicinity of private residences (Figure 17).

*Estuarine and Nearshore Habitat.* Grasser's Lagoon appears to be functioning relatively well, though it lacks a riparian buffer (Figure 18). The shoreline of Kennedy Lagoon is more modified and tidal flows are partially controlled by a tidegate. It appears to function as a recreational pond for local landowners.

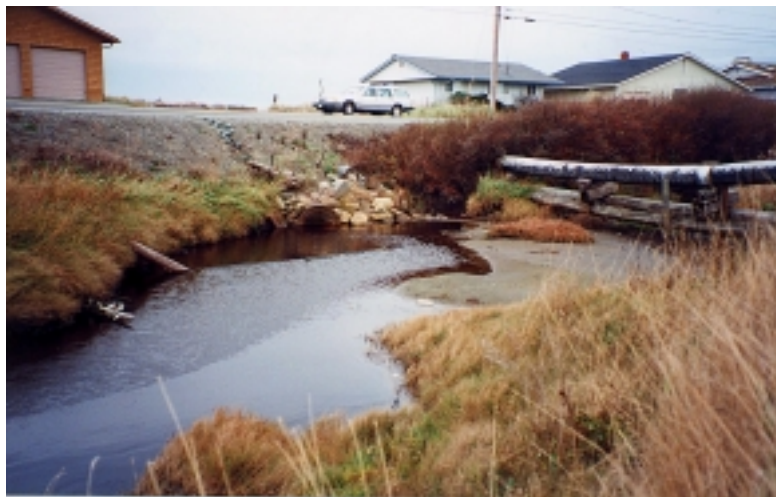
Figure 19. Tidegate at Swantown Marsh.

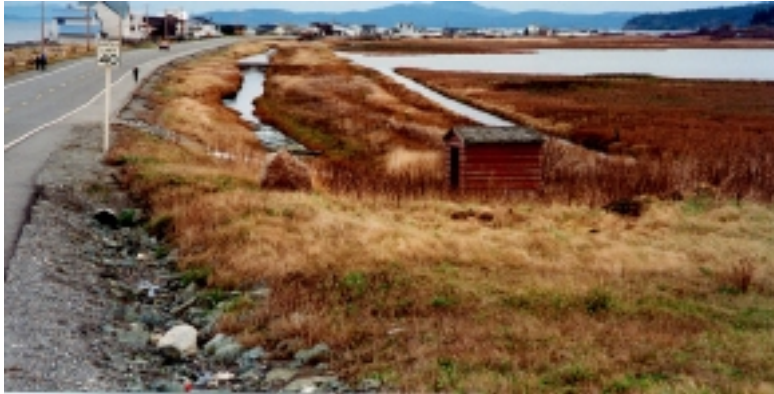
*Freshwater and Tidal Flooding.* The tidal exchange into the Swantown marsh has been modified through the construction of the berm along West Beach Road (Figure 20), and the installation of the tidegates. Several residential homes have been constructed along the shoreline between the Strait of Juan de Fuca and the marsh. The freshwater floodplain has also been highly modified through diking and ditching. During storm events, the water level in the marsh may rise above West Beach Road (which functions as a dike) and flood septic fields (KCM 1998). Future development in the upper watershed is expected to exacerbate flooding in this area (KCM 1998).

Figure 20. Swantown Marsh and West Beach Road.

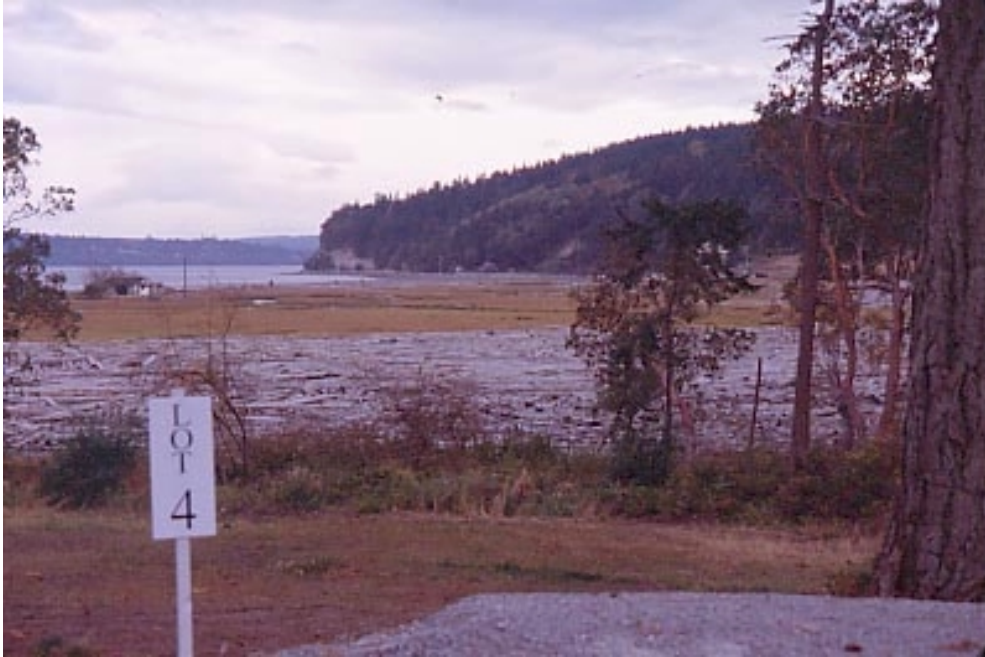
Figure 21. Elger Marsh.

*Access.* The historical topographic map seems to indicate that the sand spit now separating the Elger marsh from Saratoga Passage was constructed to allow residential development. The inlet channel to the marsh appears to be filling with sediment. The marsh is choked with thousands of logs (Figure 21). It is unknown how this may be impacting fish use of the marsh.

*Biological Processes.* Additional analysis is warranted concerning the origin of the logs within the marsh and how they might be affecting biological processes.

- Elger Marsh received only a cursory review from the TAG. Additional information is needed concerning the history of the marsh and the logs within it, the origin of the sand spit, and whether the spit has contributed to a reduction in the channel inlet. View lots are still for sale on the spit.

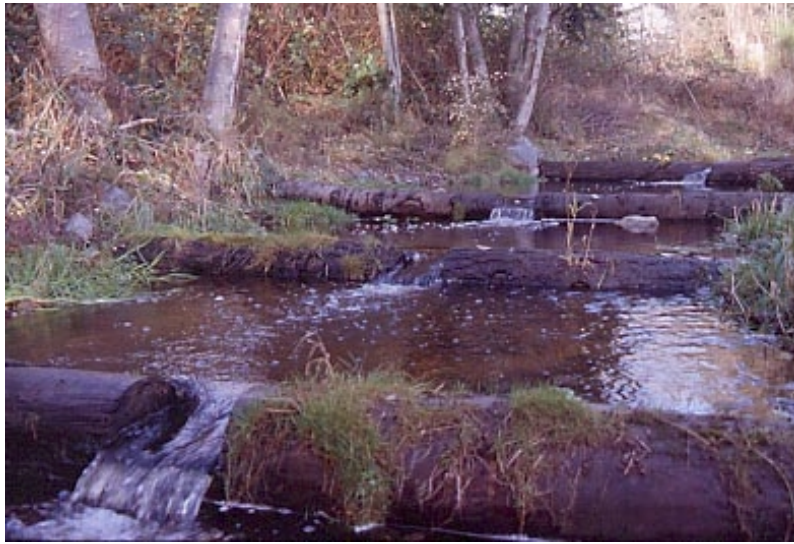
Figure 22. Fish wiers on Chapman Creek.

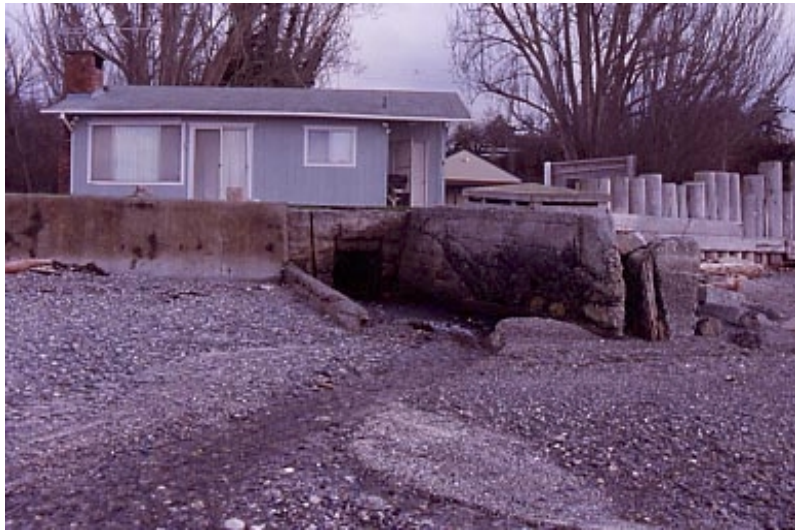
Figure 23. Nearshore and mouth of Chapman Creek.

*Estuarine and Nearshore.* Bulkheads associated with residential development (Figure 23) have heavily altered the nearshore habitat.

- Explore acquisition options at the mouth of the stream.

- Replace the culvert and outfall at West Camano Drive to allow for fish passage, and build a set of structures to address gradient concerns.
- Remove invasive exotic vegetation at the identified locations along the stream corridor.
- Re-route the creek out of the ditch and into the adjacent wetland near the pond.
- Add root balls to the pools associated with the pond to provide instream cover.
- Provide protection for the riparian buffer through acquisition or easements, and initiate partnerships with local landowners to conduct riparian restoration projects.
- Identify and protect the headwaters.
- Develop an action plan to restore and manage the stream system for the reestablishment of coastal cutthroat and anadromous salmon.

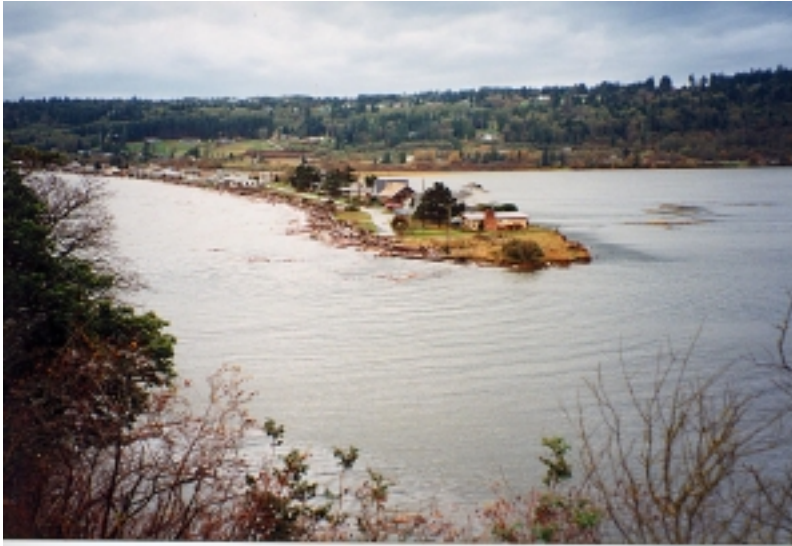
Figure 24. Sand spit at Triangle Cove.

*Estuarine and Nearshore.* A northeast-trending sand spit separates Triangle Cove from Port Susan (Figure 24). The spit is lined with residential homes on each side of the access road.

- Explore acquisition options for Triangle Cove.
- Explore acquisition options for the property riparian to the stream between Triangle Cove and Russell Road. Remove the dam from the stream on the private property and restore the stream channel.

- Continue *Spartina* control work within Triangle Cove and annual monitoring to prevent reinfestation.
- Close or remove the County dirt road to restore an open stream channel into the estuary. If it is not feasible to do this replace the 3 culverts with a large arched culvert.
- Replace the culverts at Russell Road with a larger bottomless arched culvert.
- Provide protection for the riparian buffer through acquisition or easements, and initiate partnerships with local landowners to conduct riparian restoration projects.
- Identify and protect the headwaters of the stream.
- Develop a plan to restore and manage the stream system for the reestablishment of coastal cutthroat and anadromous salmon.
